## **STAR SSD ladder status**

Before upgrading the SSD with new readout electronics, it has been asked to SUBATECH to test all the SSD ladders including the spare ones. This document is the report of the ladder tests and repair if possible.

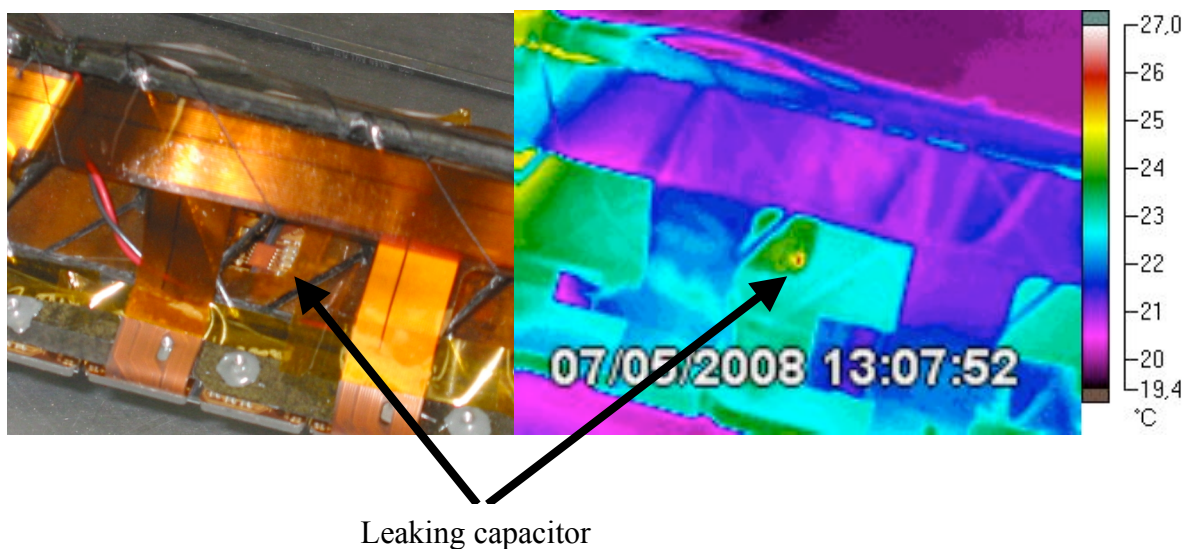
- Few ladders have a high leakage when biased
- This problem was located and it comes from one or two modules.
- The SSD detection modules have been equipped with high voltage coupling capacitors to reduce the noise picked up by the high voltage power supply coming from the south platform.
- Those capacitors are probably responsible for the high leakage current.
- So what has to be done is: to identify the capacitor, to remove it from the module and if possible to replace it.
- This operation will need a special tooling and can be dangerous for the rest of the ladder. So that must be investigated before starting the repair.

It will be confirmed if the leakage is coming from the HV coupling capacitor by using a thermal camera (image on right).

A window has been opened in the kapton layer (dedicated to air flow) and after biasing the ladder (only the high voltage) one can see the leaking capacitor hotter than the other components on the hybrid circuit. The ladder was biased at 45V and the high voltage current was around 800 $\mu$ A.
