# Graphiques

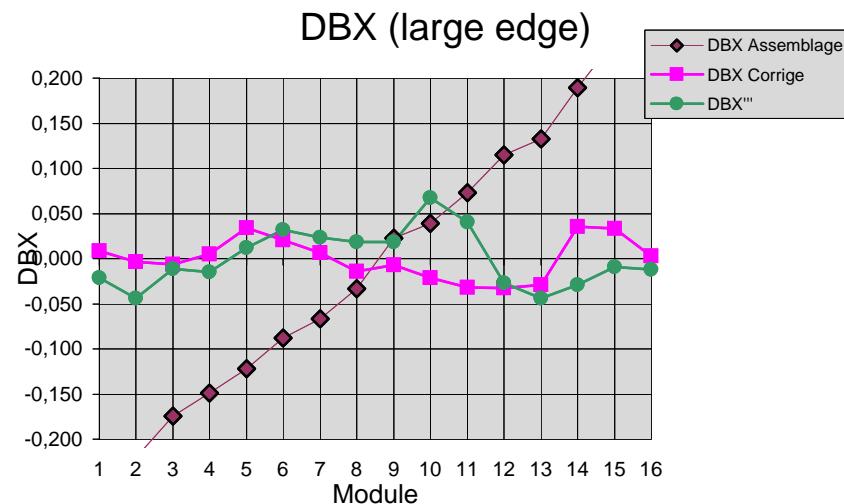
Rotation in the wafer plane

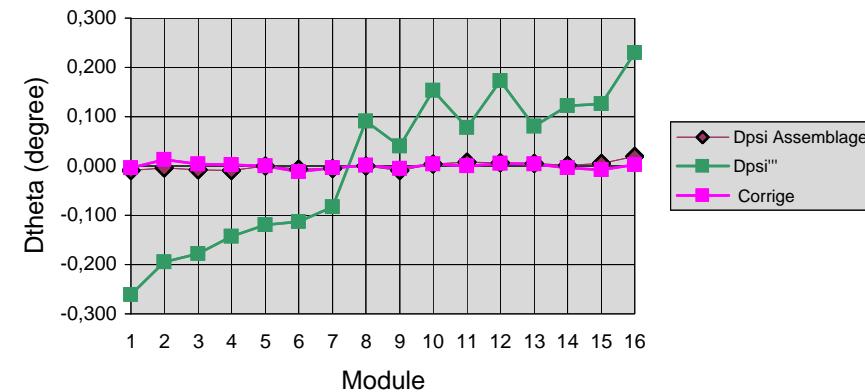
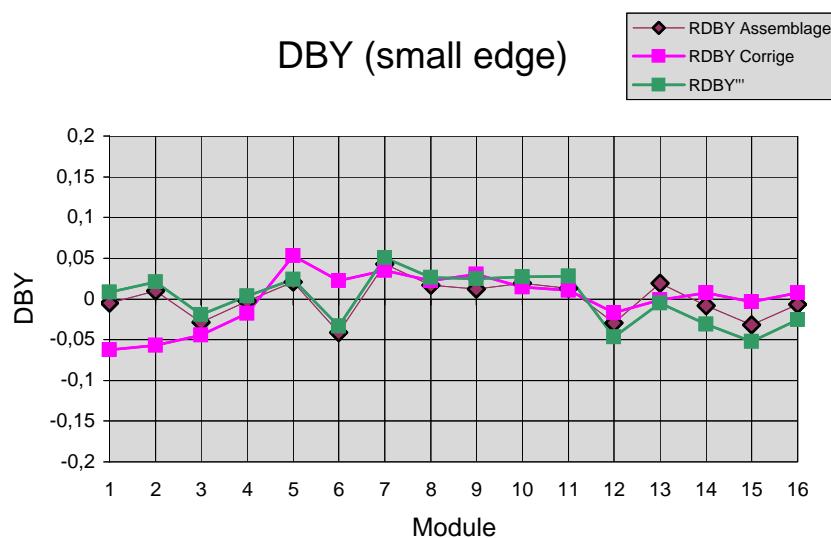
Ass. Order	1
Lad	5
Position	
Run IV	3
Run V	9
Run VI	9

Ladder tilted during the survey. Inconsistent results between data from the ladder assembly (pink), data from the raw ladder survey (purple) and the ladder survey data corrected for the tilt (green)  
THE ANALYSIS MUST BE REFINED
